# Technical Bulletin

Driving your brakes crazy!

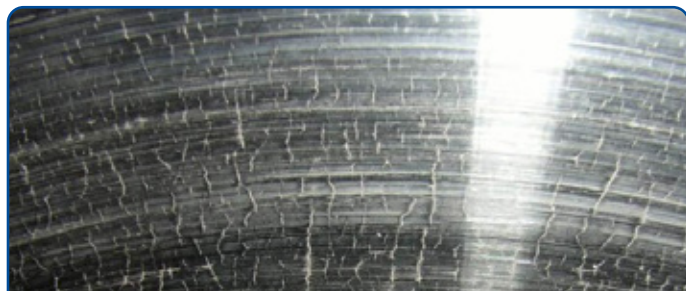
**Brake disc “crazing”, sometimes known as “orange peeling” or “crazy paving” effect is when a cluster, or multiple clusters, of small, hairline cracks appear on the braking surface of the disc. These clusters can vary in size and should be relatively easy to spot, particularly if the vehicle features an open-style alloy wheel.**

Such cracks are typically caused when the disc is exposed to high-temperatures and would potentially indicate that the motorist is working the brakes quite hard – quite literally driving their brakes “crazy”.

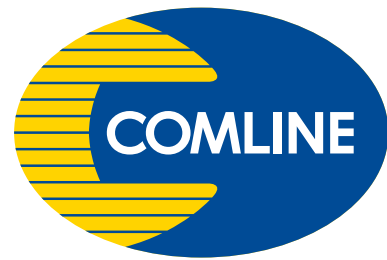
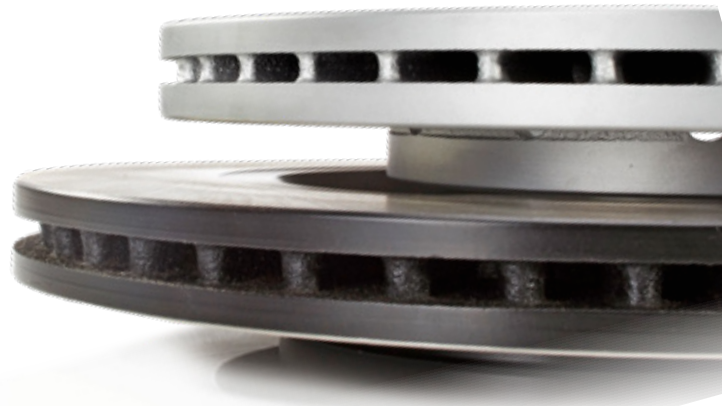
Close up of “crazing” on disc surface

brand of disc. It is something that all traditional cast metal brake discs are susceptible to under high temperatures. It is also not a problem that should cause undue concern - such cracks are typically superficial and should not cause any issues beyond their unsightly appearance. That said, Comline would always recommend consulting a professional mechanic for their expert diagnosis as other types of cracks can occur within a brake disc that are potentially more serious.
