# Technical Bulletin

Driving your brakes crazy!

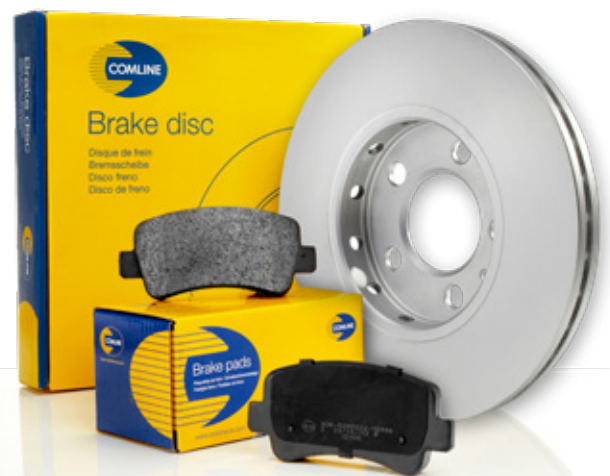
Such crazing can often present itself alongside the ‘blueing’ of the disc, whereby patches of the disc surface take on a blue tint – also a reaction to high braking temperatures. It is also possible to see disc blueing without crazing. Again, if in doubt, please consult a professional mechanic for their advice.
